# Smoke and Dye Testing Summary

## High Level Sewershed

Test ID	Test Type	Date Inspected	Company / Super.	Blower MH	Ground Condition	Notification Made?	Total Length
S1028-230	Smoke	8/12/2009	ADS/TM	S21KK_013MH	Dry	Yes	1,316.75

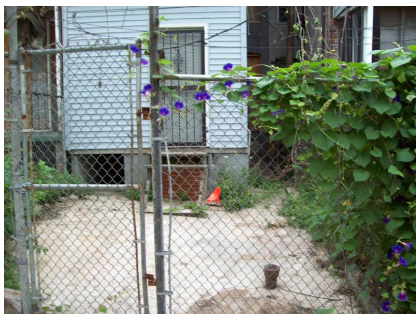
**Picture** \S1028-230-OB01-P01.jpg

**Comments** Smoke from cleanout in back yard in paved concrete patio. 2134 Fulton Ave.

**Comments** Back of house, 2134 Fulton Ave.
